Manhole Inspection Summary

Manhole # S43C2_045MH

Record Plat: **43C2** Node: **045** Status: **New Manhole (Not in GIS)** Insp Date: **4/22/09 12:00 AM**

Location Address: **1001 St. Margaret**

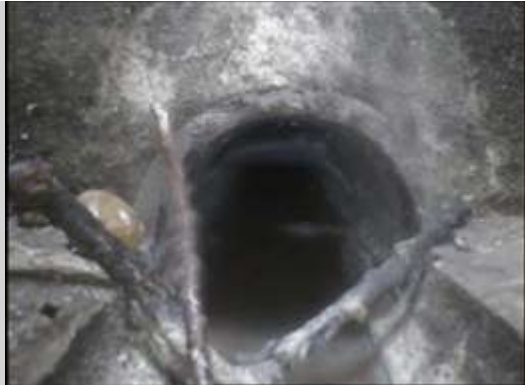
12 O'Clock Outflow

8 in. Circular Gravity Sewer
Pipe Out @ 12 O'Clock

Pipe Height: **9.6** (in.) Rod and Bar (Angled)

Pipe Material: **Clay** ☐ Pipe Lined

Invert Depth: **9.70** (ft.) Flow Characteristics: **Slow**

Deposits: ☒ None ☐ Mud ☐ Sludge ☐ Debris ☐ Grease

Infiltration: **None** Pipe Seal Cond: **Sound**

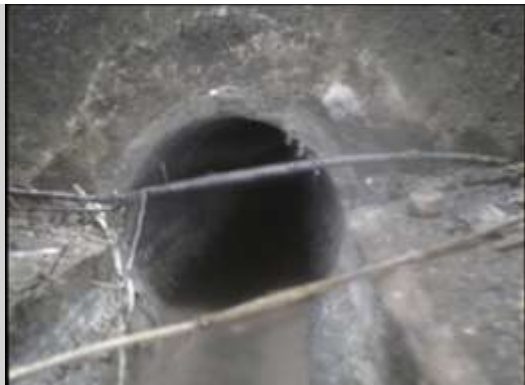
6 O'Clock Inflow

8 in. Circular Gravity Sewer
Pipe In @ 6 O'Clock

Pipe Height: **10.8** (in.) Rod and Bar (Angled)

Pipe Material: **Clay** ☐ Pipe Lined

Invert Depth: **9.85** (ft.) Flow Characteristics: **Slow**

Deposits: ☒ None ☐ Mud ☐ Sludge ☐ Debris ☐ Grease

Infiltration: **None** Pipe Seal Cond: **Sound**
